EXECUTIVE SUMMARY REPORT

GRANT REGIONAL HEALTH CENTER – EXPANSION & RENOVATION

January 29th, 2018

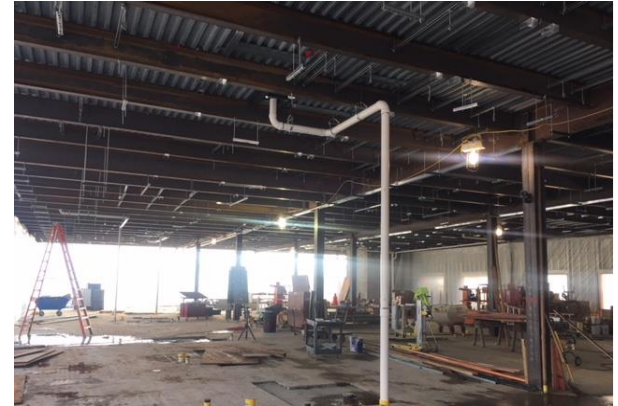
The upper level of the new addition is coming along quickly. Soon this area will be fireproofed.

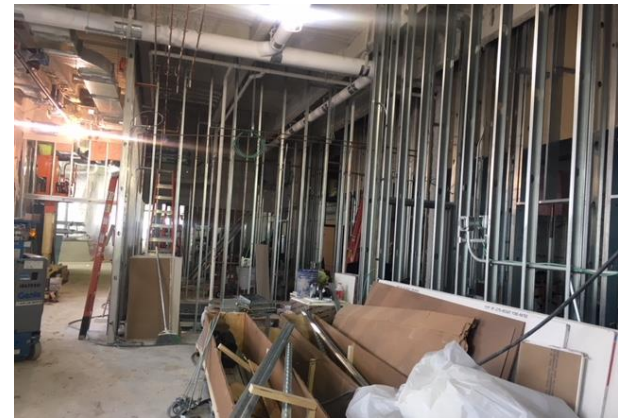
This framing currently outlines the new "Main Street" area that will feature a deli and seating.

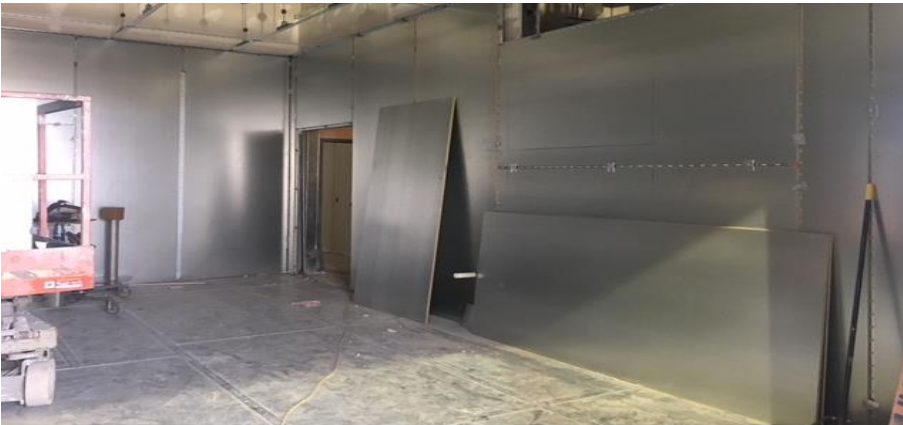
A special shielding is added to the walls, floors, and ceiling of the MRI room! This stops the magnetic force from traveling beyond the walls of that specific room.

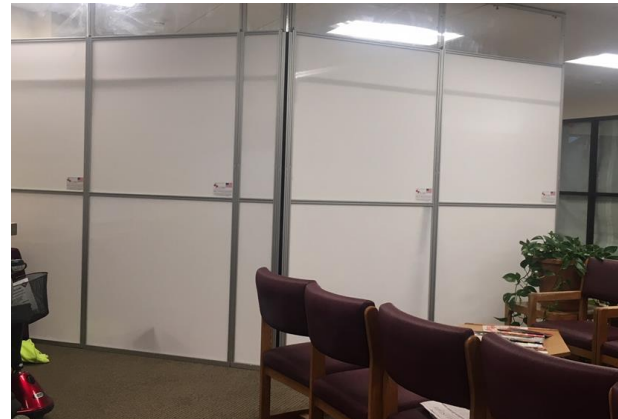
The view from the current waiting room. The crews are working behind these barriers to tie new and existing spaces together.

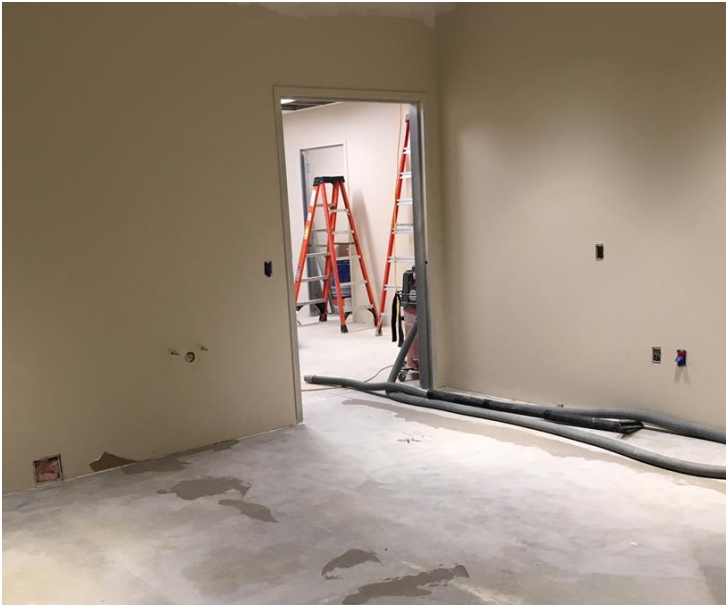
Floor prep is involved in each room before the actual flooring materials can be placed down. This helps ensure a flat floor.

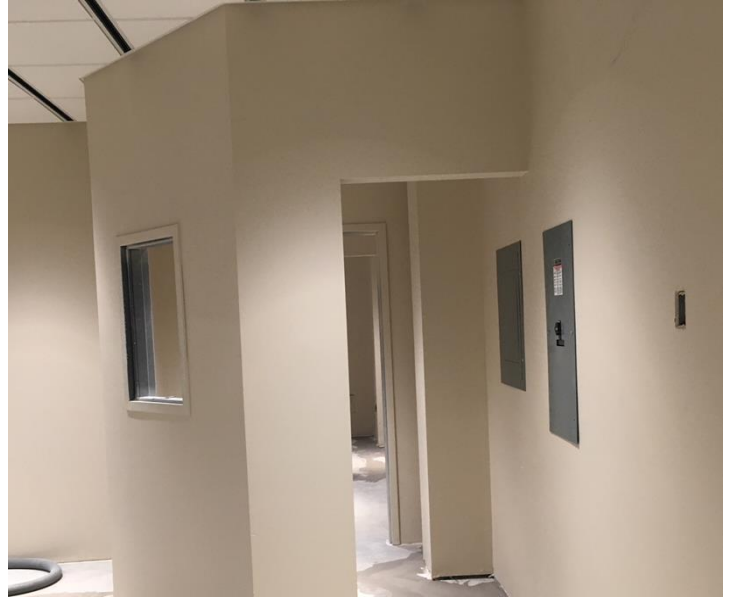
The new control room connects the Fluoro room with the X Ray room!

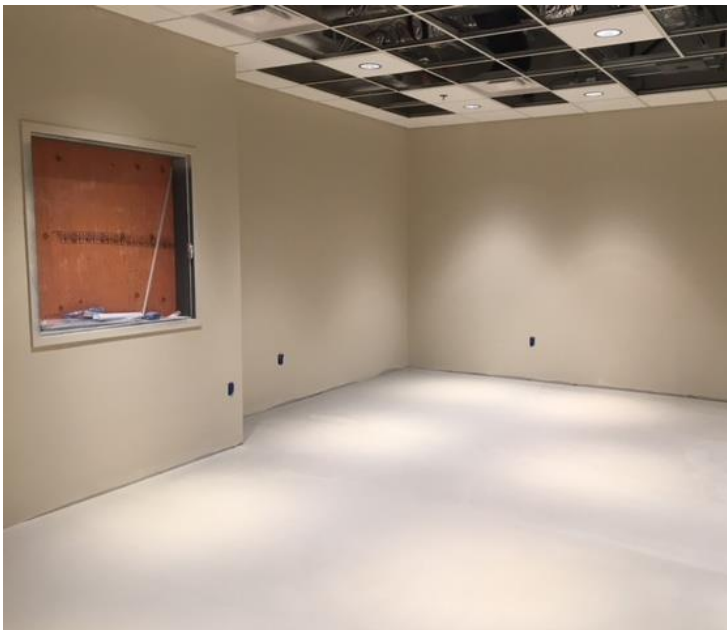
In certain Imaging area rooms, the entire floor in the room is leveled to prepare for the new equipment being installed.

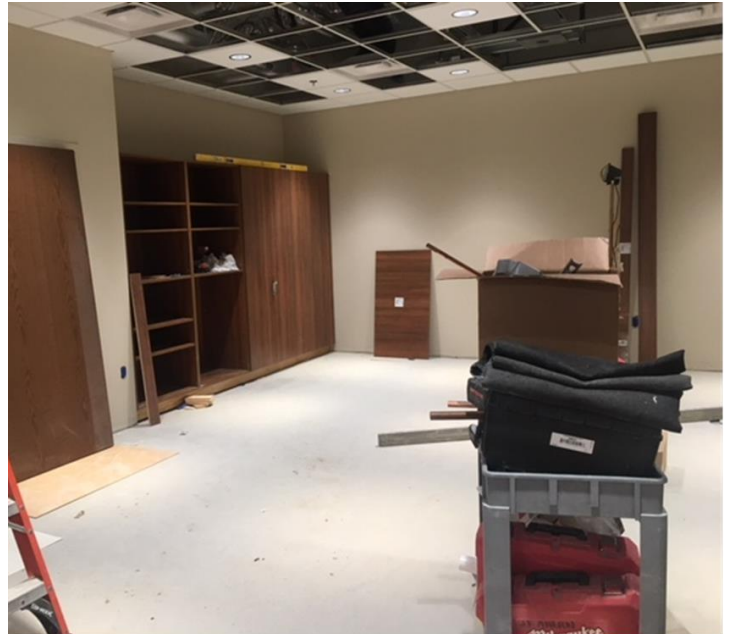
Casework is currently being installed in the Imaging area.

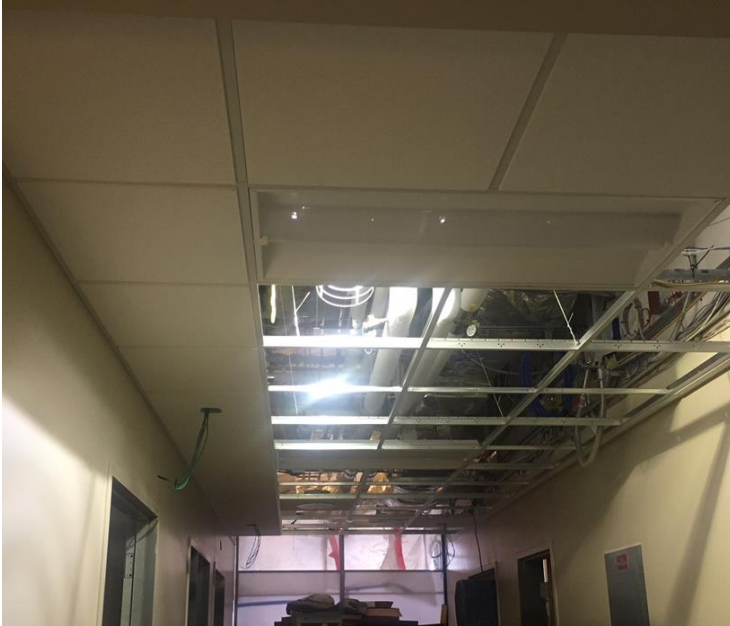
A ceiling is being added and finished up that leads into the new “Main Street” area at the end of the corridor.

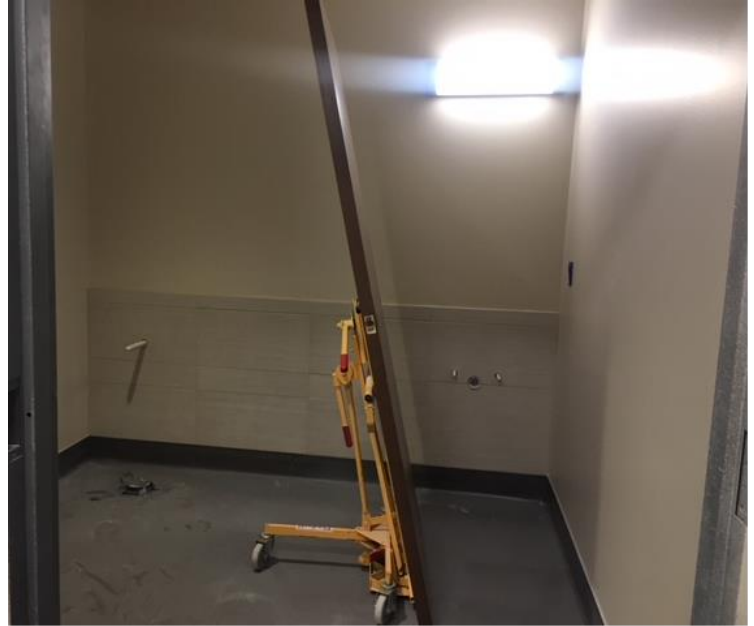
This cart, sometimes called a door jack, helps the carpenters install the doors quickly and correctly. Doors are currently being installed in the new Imaging area.

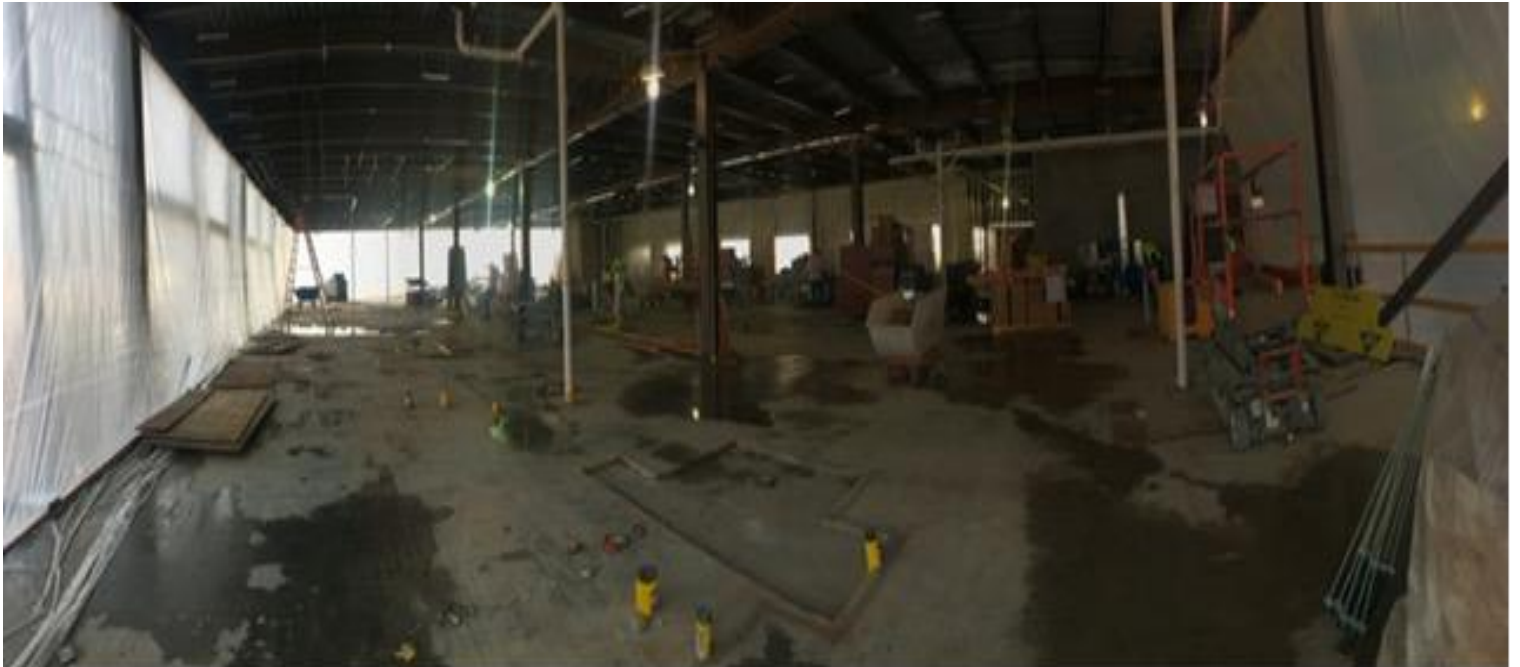
The overall view of the upper level portion of the new addition. The cut out shape in the floor towards the middle of the picture outlines where the bathrooms will be in each of the rooms. Soon walls will be added around each area to help define the space.
